Title: 2021 05 SPRING RETURN UNITS

Introduction.

In June 2021 the 05 actuator was redesigned. This includes a change to the O-ring and groove in the spring unit base plate. This supersedes the redesign of 2014 sketches below show which base plate design is compatible with the relevant age of actuator.

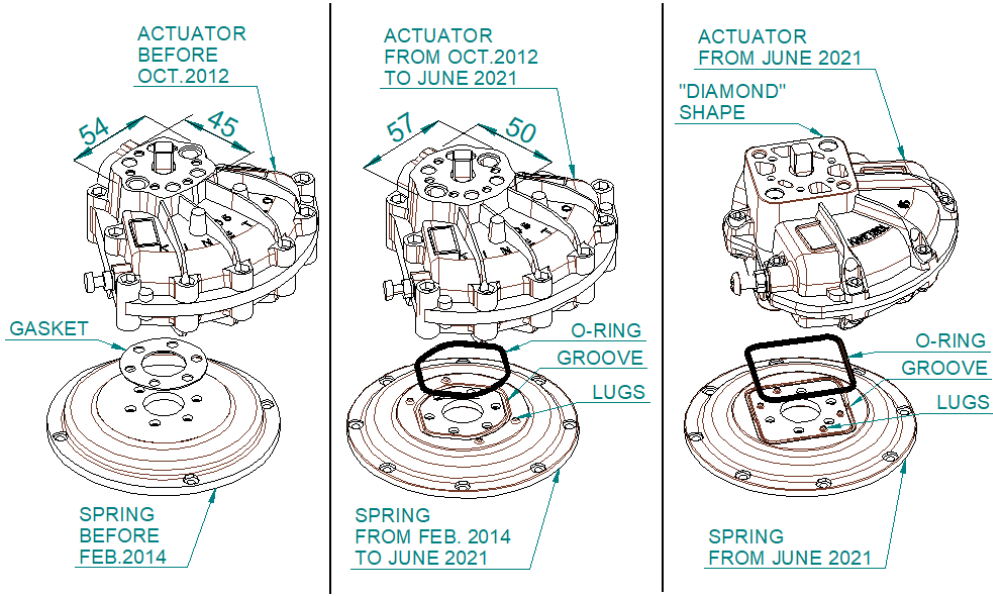
Because of the shape of the O-ring groove, it is theoretically possible to fit the spring base plate to the actuator in the incorrect orientation (i.e. 60° out of position) which could allow leakage past the O-ring. To prevent this, the base plate has lugs protruding from the cast surface; If the base plate is attached to the actuator in the wrong orientation, the lugs will prevent the face of the base plate from contacting the actuator face, creating a clearly visible gap. The correct version of base plate must be used, and **MUST** be orientated such that the lugs overhang the sides of the actuator mounting face (2014 versions), or sit within the cast recesses (2021 versions) and do not make contact with the mounting face. (see sketch below)

CORRECT BASE PLATE ORIENTATION

INCORRECT BASE PLATE ORIENTATION
